File #: C09166 009

**RE: COLUMBIA AVENUE INFRASTRUCTURE UPGRADING & REPLACEMENT STUDY**

The City of Rosland  
Columbia Avenue Infrastructure Upgrade &  
Replacement Study

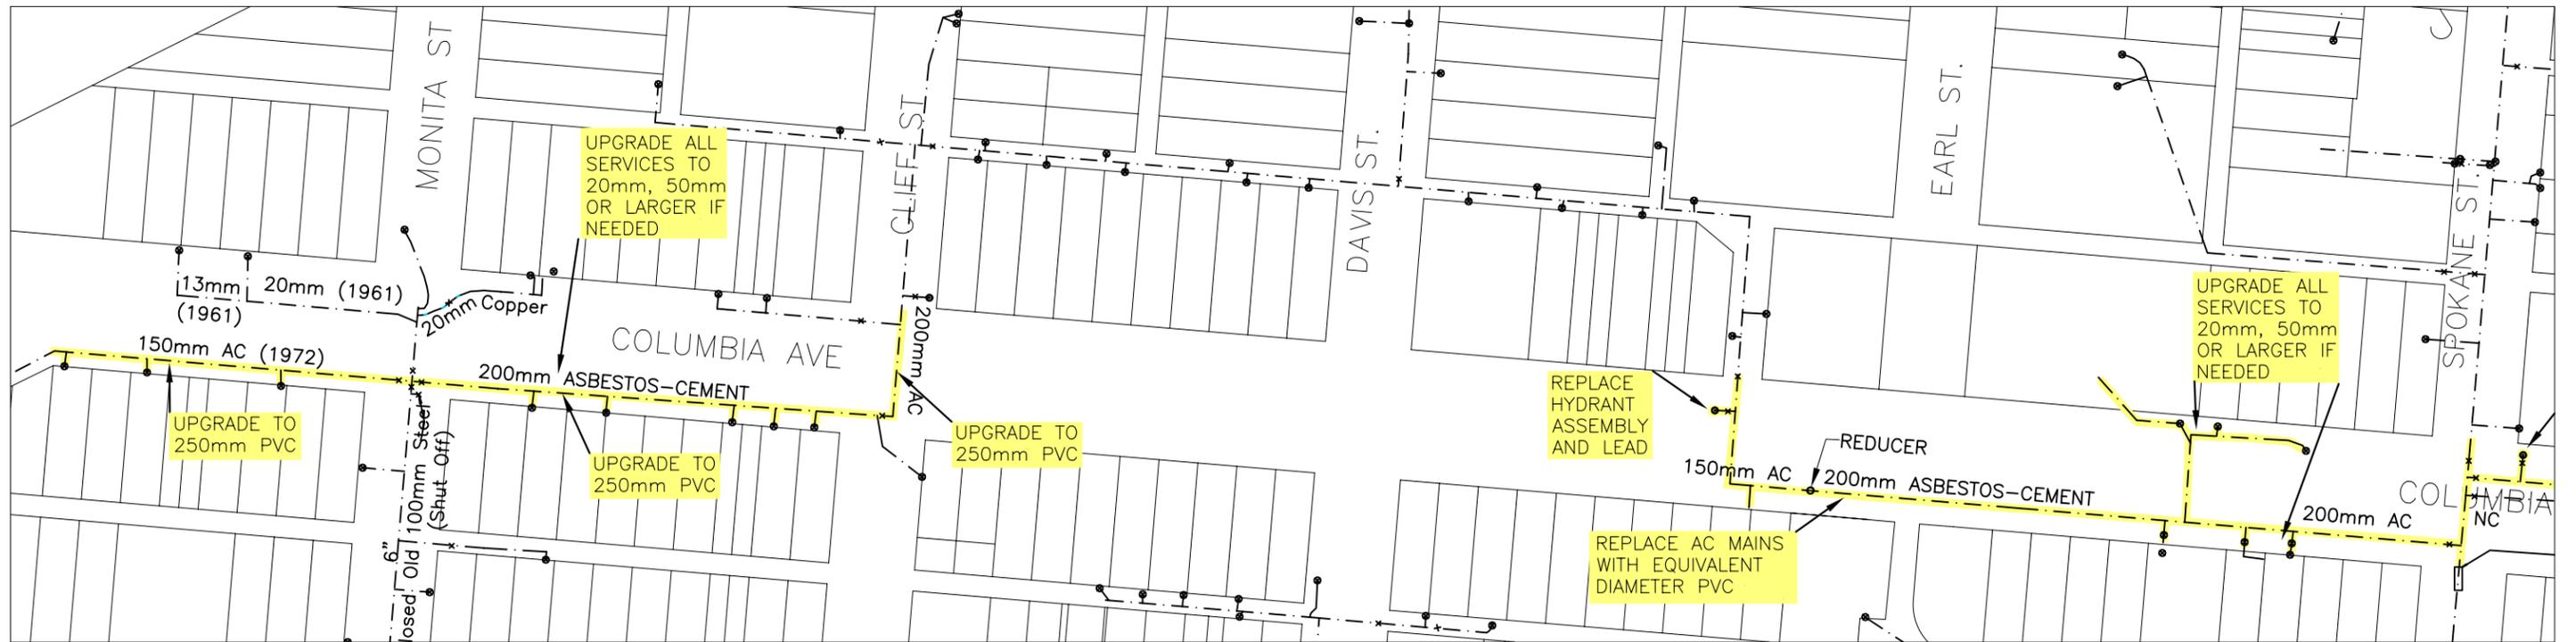
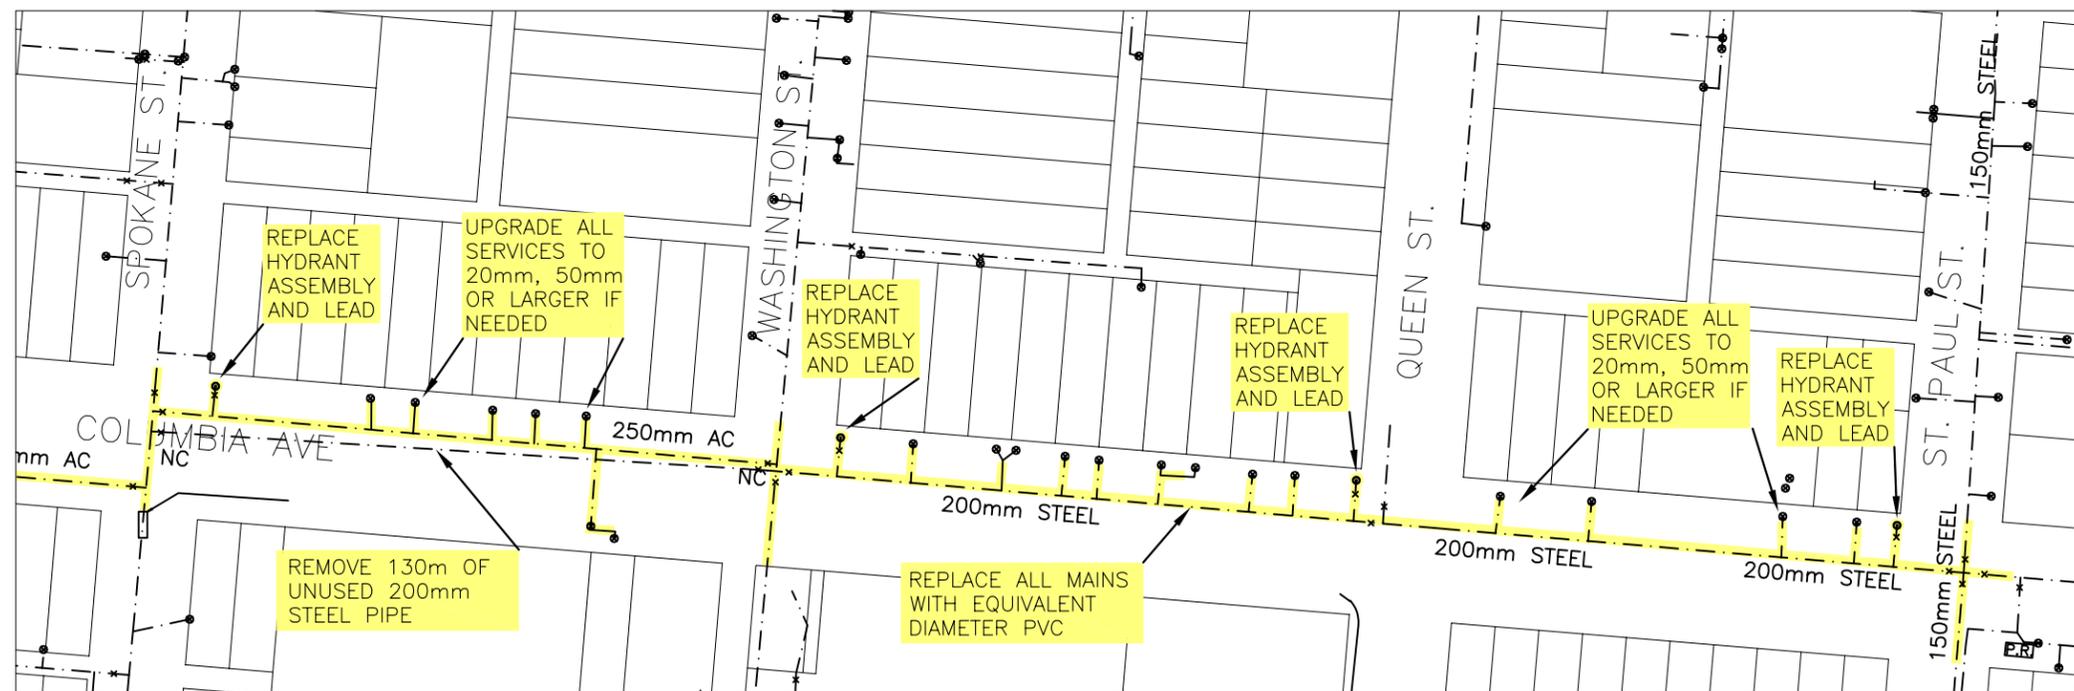
**Figure 1 – Existing Domestic Water System & Recommended Upgrades (1:1500)**

The existing domestic water system, consisting of mains, service connections, valves and fire hydrants along Columbia Ave. is very old (some piping dates back to 1930) and in need of repairs and upgrades. The City Public Works representative informed WSA that some sections of pipe along Columbia Ave. have greatly reduced capacity due to internal corrosion and deposition and that frequent repairs are required to fix leaks and ruptures.

Based on our discussions with City personnel, WSA recommends that all water mains, service connections, valves and hydrants be replaced along Columbia Avenue between Monita St. and St. Paul St. The existing infrastructure is in very poor condition and continuing the current approach of spot repairs to this system is not cost effective. All existing service connections should be replaced with a minimum 50mm dia. pipe for buildings with fire sprinklers or larger to match the existing size. For buildings with no sprinkler systems, a minimum 20 mm dia. pipe is required. For the purposes of cost estimation, 50mm services have been assumed from St Paul St. to Spokane St. and 20mm services have been assumed from Spokane St. to Monita St. Each new service is also assumed to be 10m in length.

The results from the Urban Systems 2008 “Water Model Study” were consulted to help identify water system upgrades necessary to provide adequate pressure and fire flows to new housing developments in Rossland. The study recommends increasing the 200mm dia. main coming down Cliff St. and crossing Columbia Ave. to a 250mm dia. The 200mm dia. AC main continuing west on Columbia Ave. is to remain as is but it is recommended to increase it to 250mm dia. after it turns south down Nevada St. WSA recommends that during the upcoming resurfacing, the 200mm dia. main on Columbia Ave. between Cliff St. and Nevada St. also be upgraded to 250mm dia. PVC.

It is recommended that all water mains be replaced with equivalent diameter PVC piping and that the old mains and services that are replaced be removed to facilitate efficient installation and future repairs on Columbia Ave.

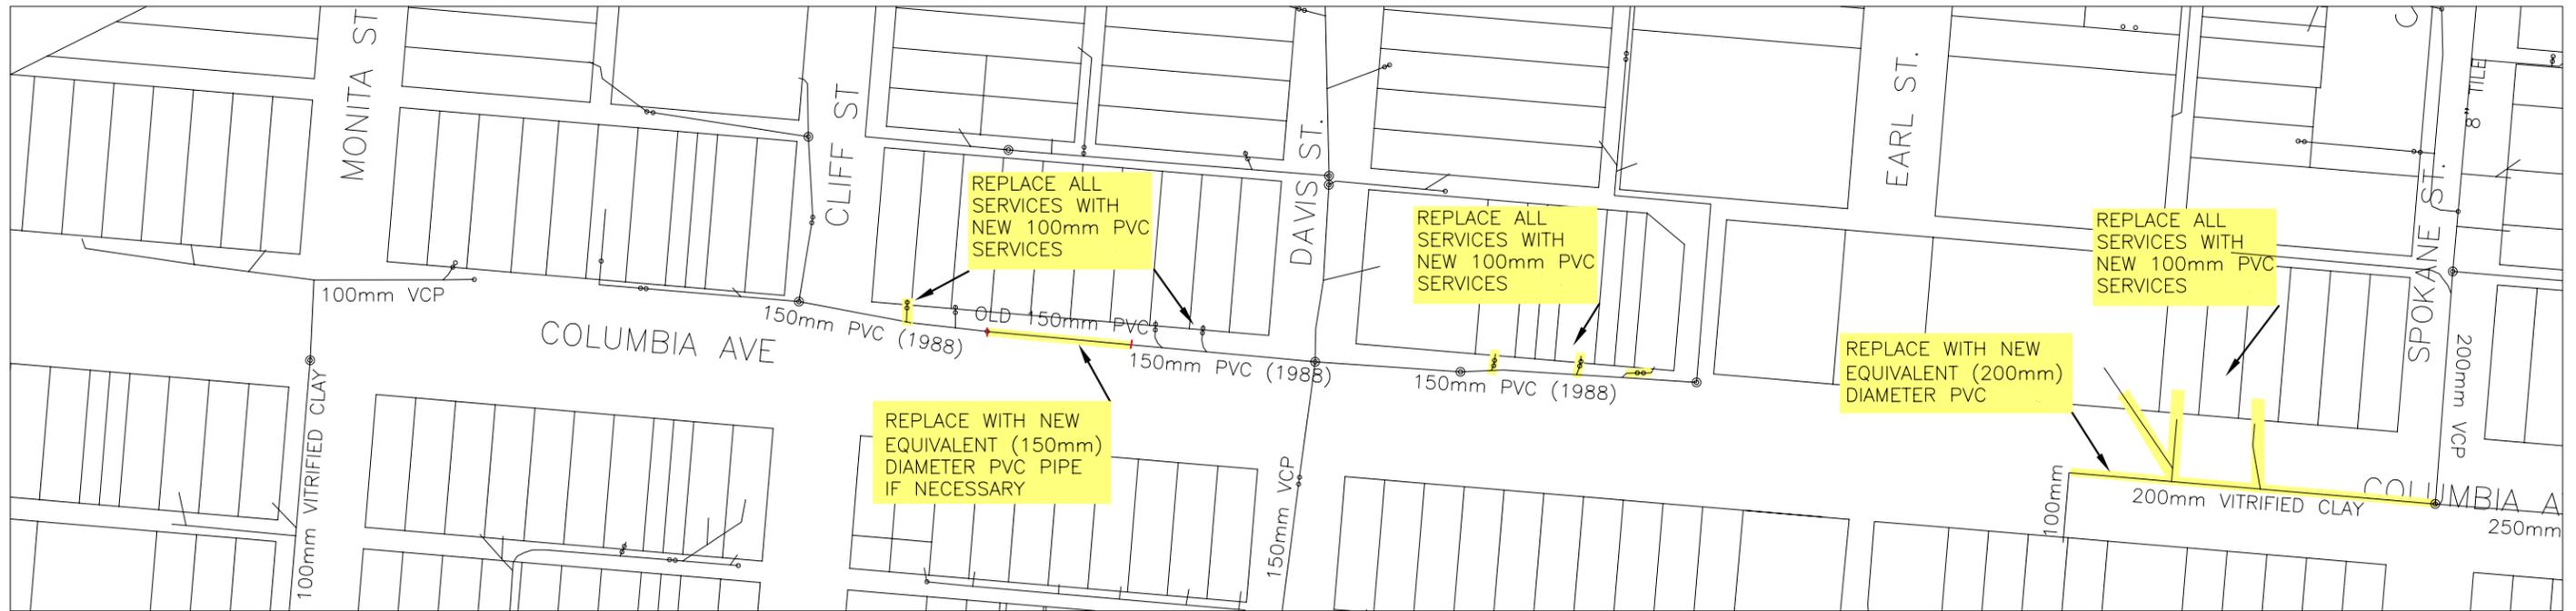
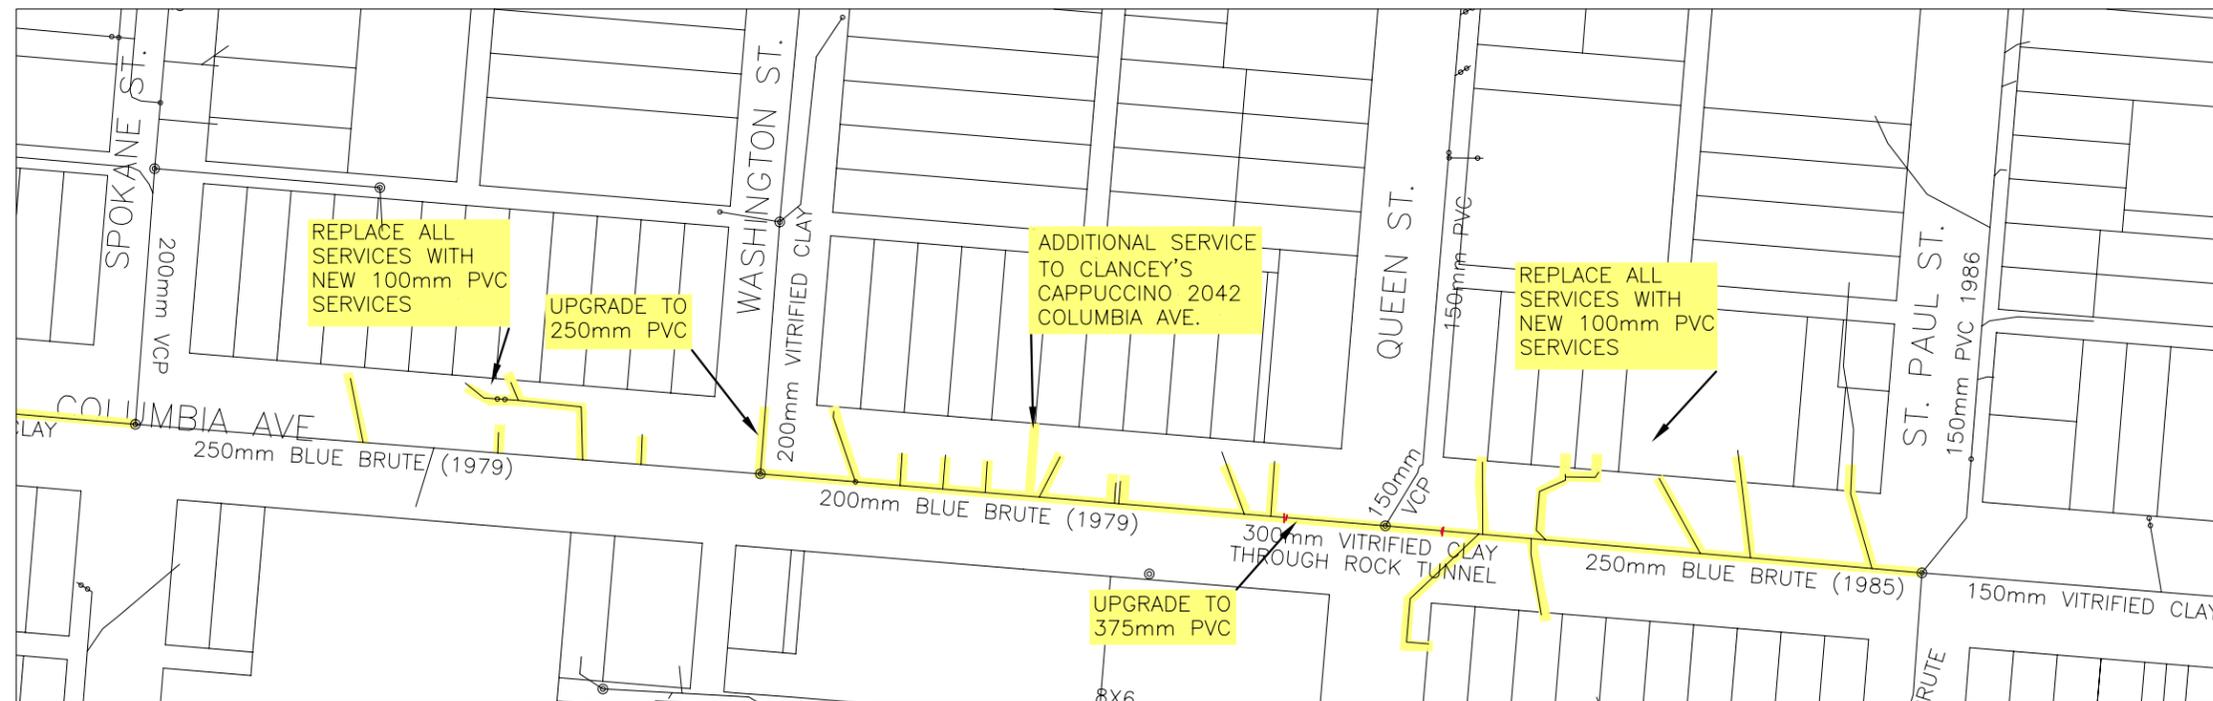
**Figure 2 – Existing Sanitary System & Recommended Upgrades (1:1500)**

Moving west to east on Columbia Ave. between Cliff St. and Davis St. are several sections of sanitary sewer main (see Fig. 2 for sanitary sewer details). Approximately 45m of 150mm dia. PVC installed in 1988 is followed by 30m of old PVC (age and diameter unknown). Continuing to the east of the old PVC is 45m of 150mm dia. PVC (1988). There are 4 services on this block. None of the services appear to originate from the section of old PVC pipe.

The majority of sanitary sewer mains are composed of PVC pipe installed within the last 20-30 years. However, there are several short sections of main which should be upgraded (see Fig. 2). There is a 30m section of old PVC pipe located between Cliff St. and Davis St. Information

about the age and condition of this pipe is not known, and it should be replaced if found to be degrading. Between Earl St. and Spokane St., the existing 200mm dia. VCP should be upgraded to 200mm dia. PVC pipe. Between Washington St. and Queen St. there is a 30 m section of 300mm dia. VCP located within a rock tunnel that should be replaced.

The “City of Rossland – Red Mountain Sector Planning Report” prepared by Urban Systems in 2003 lists the sanitary main on Columbia Ave. between Washington St. and St. Paul St. as requiring an upgrade. The report recommends that the existing 250mm Blue Brut pipe and the section of 300mm VCP be upgraded to 380mm PVC. Table 2 provides a summary of recommended upgrades and a cost estimate for the work. Detailed cost estimates for all work required for recommended sanitary sewer upgrades are included at the end of this report in Appendix A.

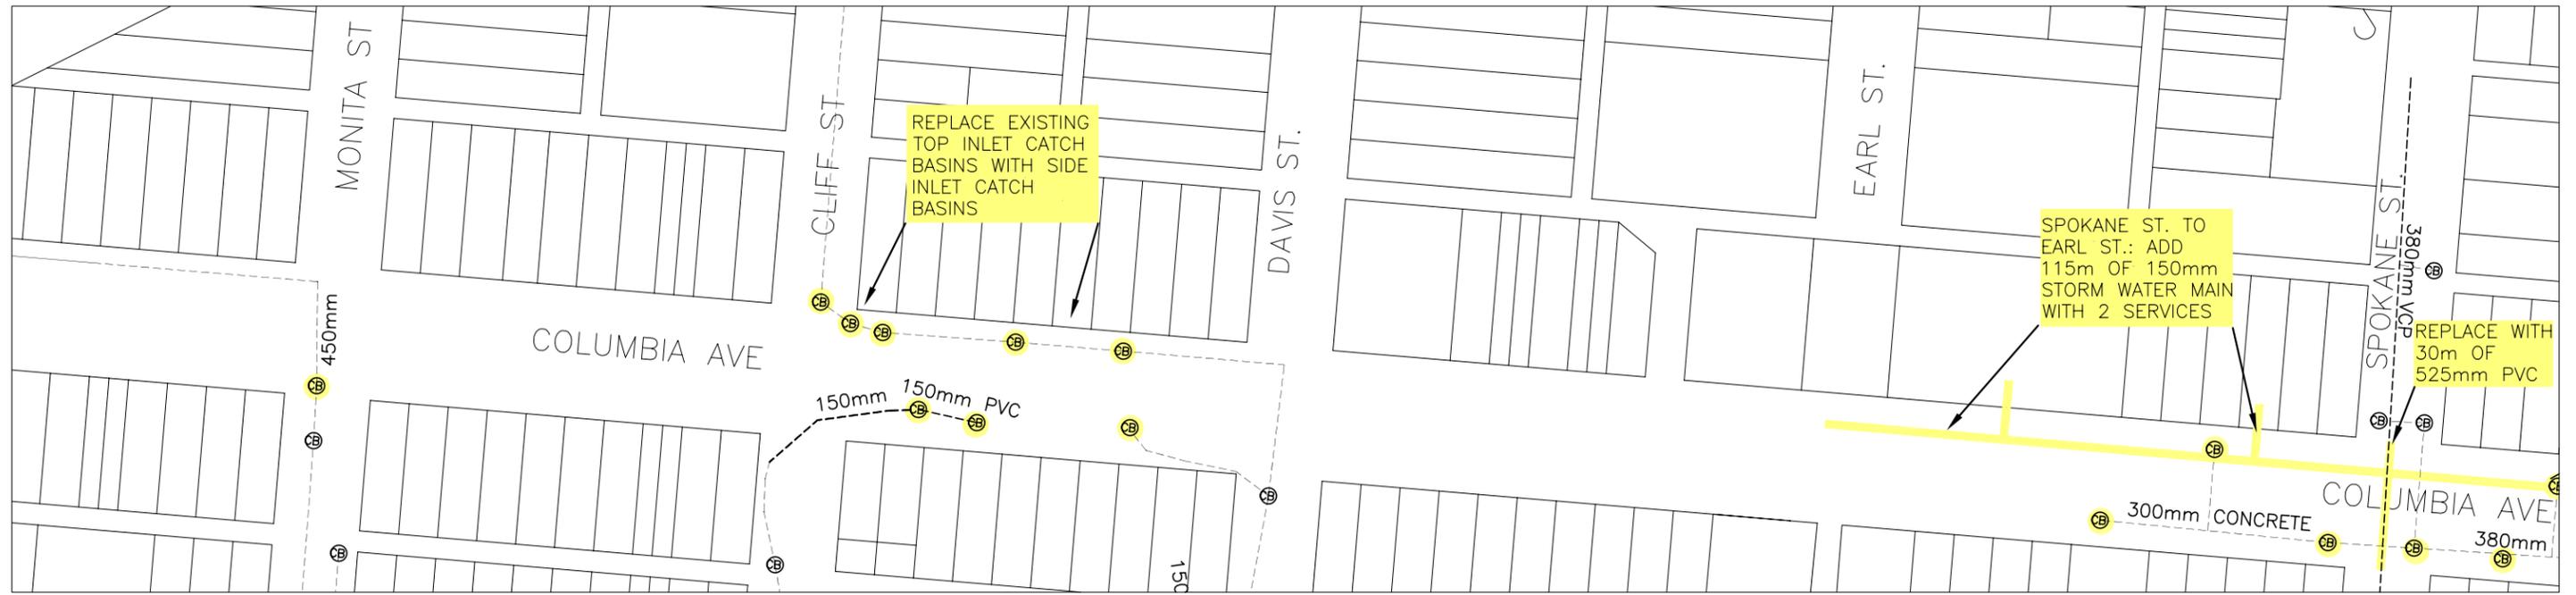
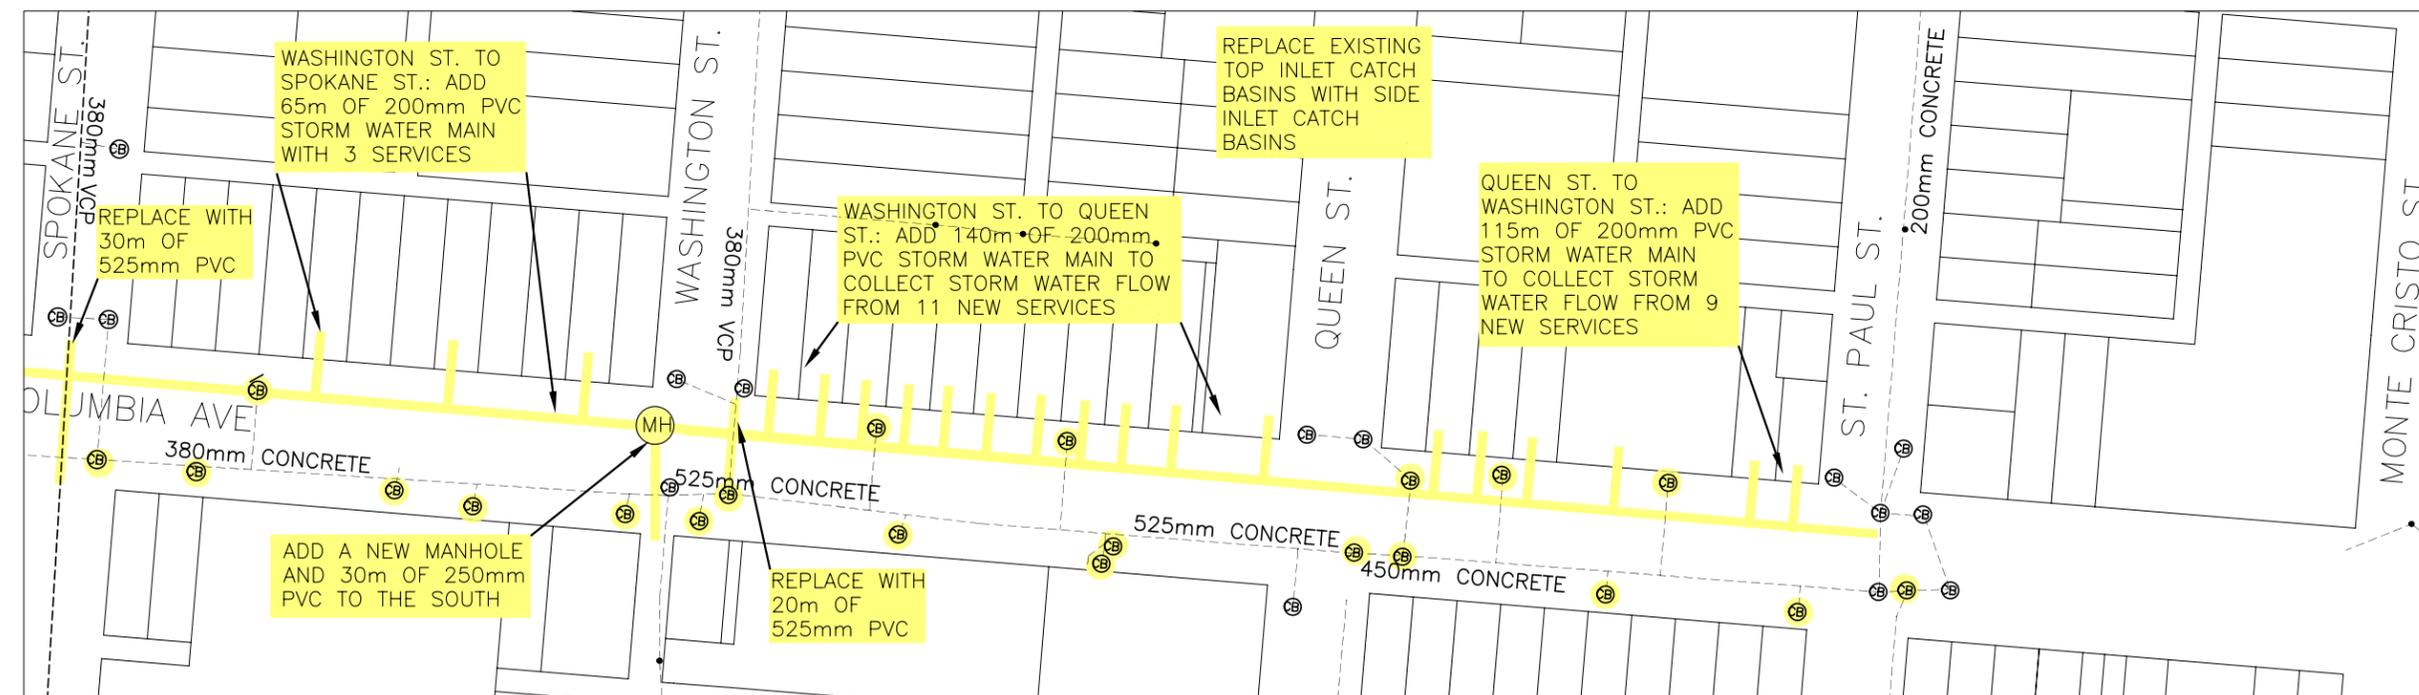
**Figure 3 – Existing Storm Water System & Recommended Upgrades (1:1500)**

The existing storm water system along Columbia Ave. consists of various sizes of concrete, PVC, and vitrified clay pipe (VCP) which collect storm water runoff from catch basins and direct it to Washington St. where the storm sewer heads down hill in a southerly direction (see Fig. 3 for storm water system details).

Most of the existing storm sewer pipes along Columbia Ave. are functioning well and do not need to be replaced. The City of Rossland's "Master Drainage Plan" prepared by Reid Crowther & Partners Ltd. in 1995 gives some recommendations for future upgrades to the storm sewer system. Two of these upgrades are in the vicinity of Columbia Ave. and WSA recommends that the portion of these upgrades that cross Columbia Ave. be completed during the highway resurfacing (see Fig. 3). The first of these is a medium priority upgrade to increase the size of the vitrified clay storm water pipe coming down Spokane St. and crossing Columbia Ave. from a 380mm to a 525mm. During the resurfacing, the portion of this clay pipe crossing Columbia Ave. should be replaced with a 525mm PVC pipe.

The second recommendation is a low priority upgrade to increase the size of the vitrified clay storm water pipe coming down Washington St. from a 380mm to a 525mm. The portion of this clay pipe crossing Columbia Ave. should be replaced with a 525mm PVC pipe during the resurfacing.

According to the City, the current number (33) and spacing of catch basins is adequate for storm water removal and no additional catch basins are recommended. However, City representative stated that the existing top inlet catch basins should be upgraded to top and side inlet catch basins to increase storm water capture.

In order to eliminate the cross connections from the roof leads along Columbia Ave. to the sanitary sewer, the following recommendations are given. The City should conduct dye testing to confirm which roofs actually drain into the sanitary sewer. It is believed that the roof leads for the buildings go down into the basements and connect to the sanitary services. Since the existing storm sewer on Columbia Ave. is relatively shallow (76 cm – 200 cm deep), a new storm water collection pipe will need to be installed at a greater depth in order to attach the new storm water services. This collection main has been sized to have the capacity to carry the 25-year storm event. It will run from west of Spokane St. to Washington St. and east of St Paul St. to Washington St. The new main will then head south down Washington until it can connect to the existing 525mm storm sewer. Table 3 lists the proposed storm sewer upgrades showing pipe sizes, lengths, and estimated costs. Detailed cost estimates for all work required for recommended storm water system upgrades are included at the end of this report in Appendix A.
